SolarMagic™ Helps Balance Underperforming Array. Production Boosted by 21.7%.

Site: Northern California Bay Area High School
 System Size: 440 kW
 Modules: 2508 SolarWorld 175W mono
 Strings: 209
 Inverter: Xantrex
 Monitoring: Obvius Modbus and ModHopper. (AC only)
 Installation date: October 2008

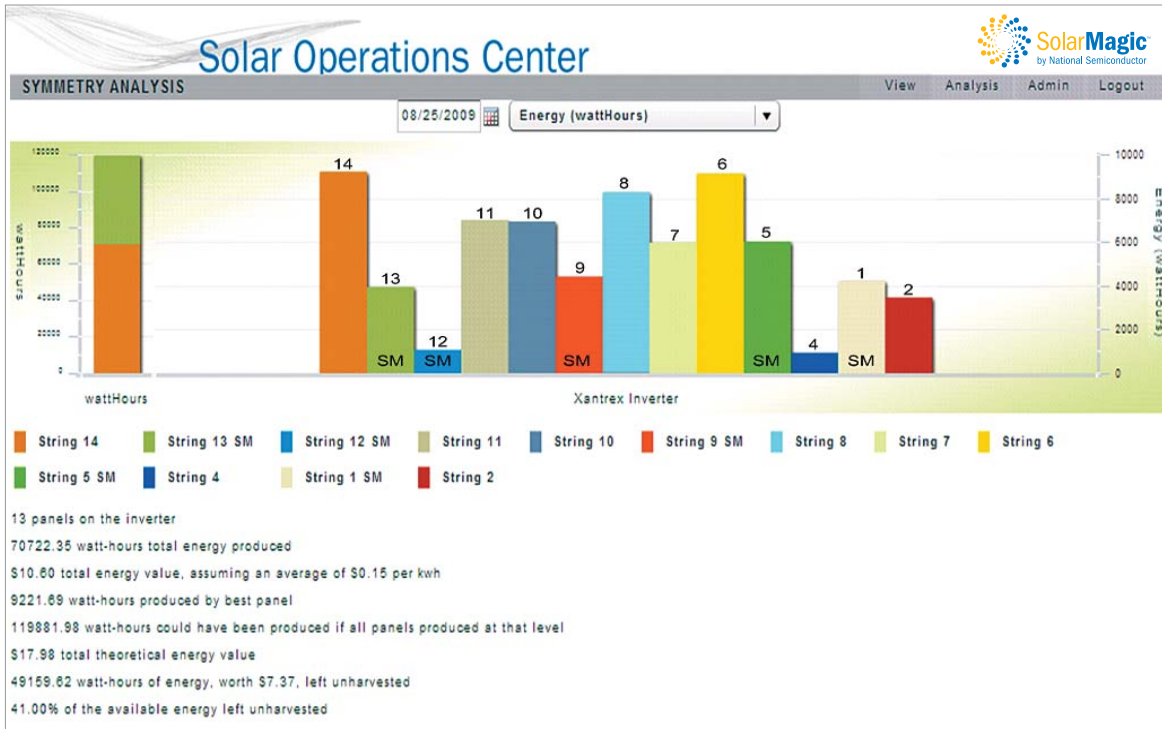
Figure 1: Solman Symmetry Analysis on August 25th 2009 shows significant underperformance, even in completely undamaged strings. Strings 1, 5, 9, 12 and 13 have at least 2 panels each damaged by baseballs. Cumulatively, these strings were underperforming by over 30% (after normalization).

Figure 1 shows a representative day during the performance evaluation phase. Strings 6 and 14, SolarMagic’s control strings, were performing well, and set a baseline for the subarray. If all strings had performed at this level, the subarray would have produced 120 kWh, but the damaged strings (plus the control strings) only produced 71 kWh of energy. **Figure 1** shows this left 41% of the energy entitlement unharvested. After normalizing the data for weather, irradiance, and a blown fuse in string 4, 31% of energy potential proved to be left unharvested.

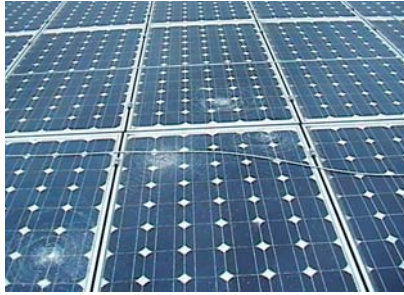
Figure 2: Baseballs cause starburst breakage patterns in the module glass and can damage underlying cells.

Of the fourteen strings evaluated in this case study, five had damage by at least two fly-balls. **Figure 2** shows 3 modules with breakage caused by baseballs. Even though other strings were also underperforming, only these strings were selected for assistance by SolarMagic power optimizers. In September 2009, strings 1, 5, 9, 12 and 13 were optimized with SolarMagic. Results are illustrated in **Figure 3**.

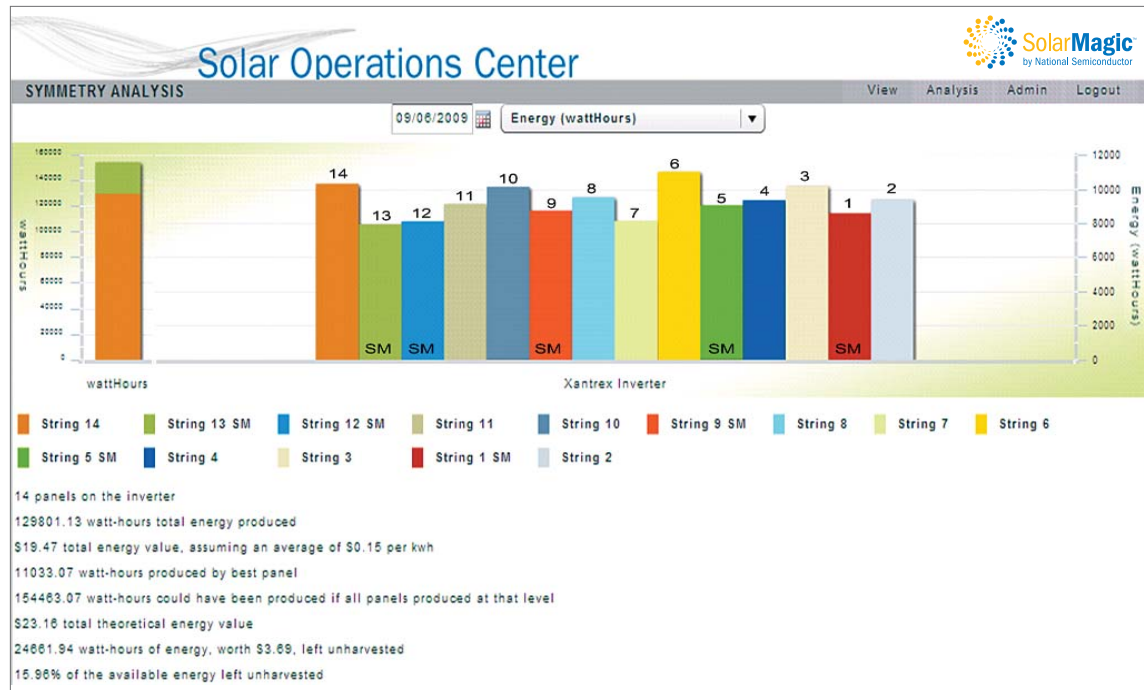
Figure 3: Solman symmetry analysis on September 6th shows significant improvement in energy harvest both from SolarMagic assisted strings, and other strings in this subarray.

Figure 3 shows significant improvement in energy harvest. Even with damaged modules in most strings, SolarMagic power optimizers balanced the system enough to reduce the power loss from 31% to under 16%. Even unassisted strings benefited when the worst performing strings were instrumented with SolarMagic power optimizers. This translates to recapturing 51.2% of previously lost energy.
